MINE No. 60 - POND 6 (NDI Number
PA 01145, PENN DER Number 63-89)

PHASE I INSPECTION REPORT.

PHASE I INSPECTION REPORT
NATIONAL DAM INSPECTION PROGRAM

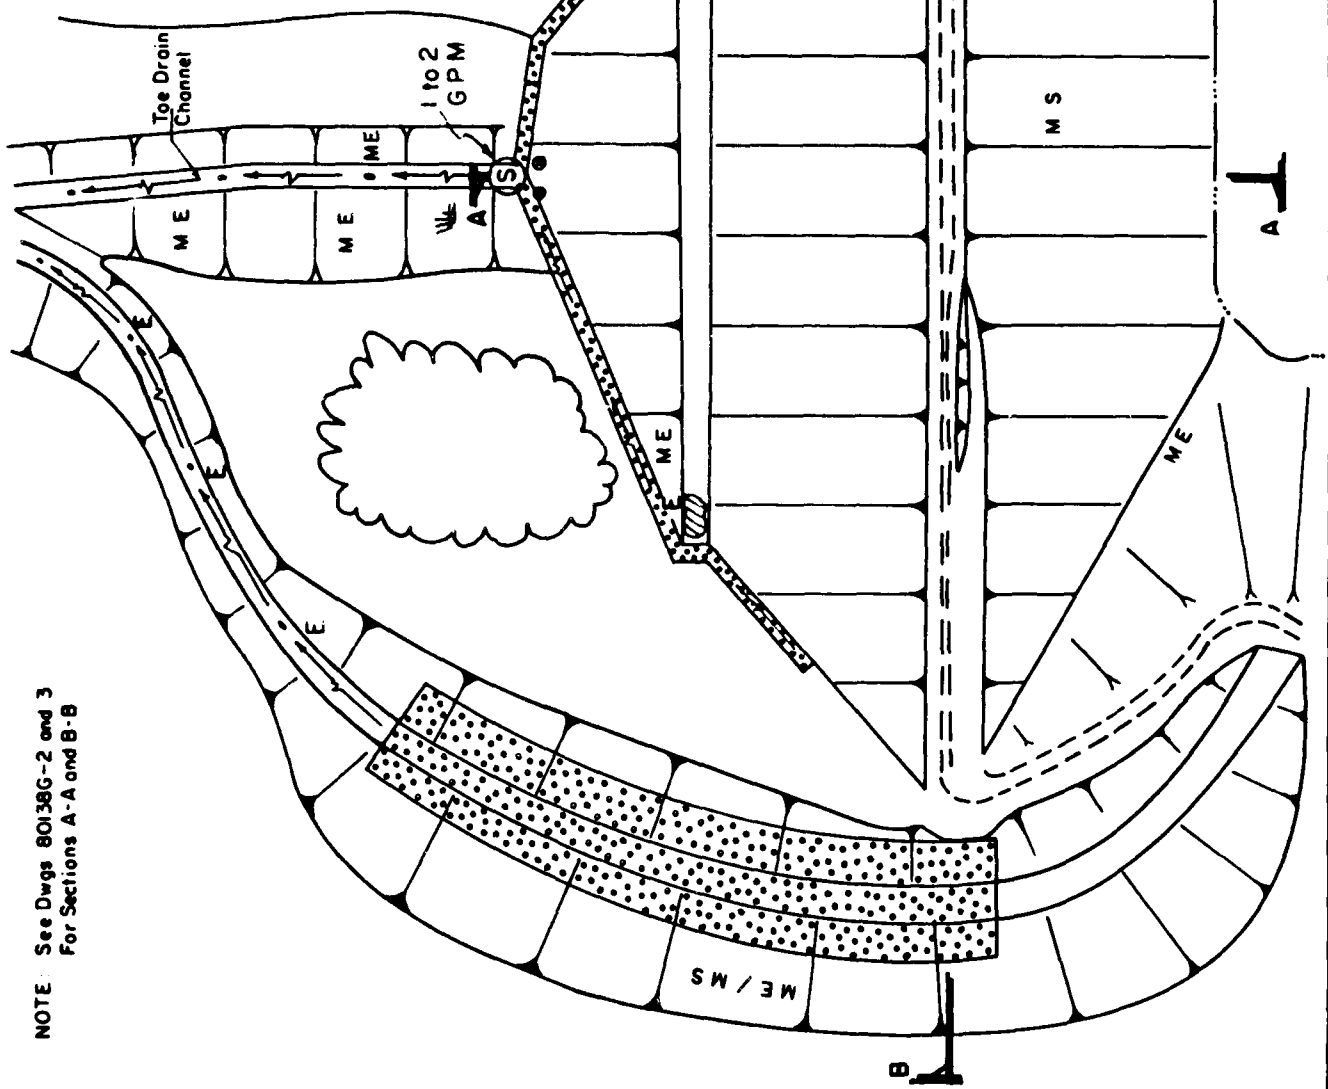
DATE: MAY 1981	MINE No. 60 - POND 6	FIELD SKETCH
SCALE: NONE	NATIONAL DAM INSPECTION PROGRAM	
DR: JF CK: JEB	ACKENHEIL & ASSOCIATES CONSULTING	
DWG. NO. 80138G-1	GEO SYSTEMS, INC. ENGINEERS 1000 BANKSVILLE RD./PITTSBURGH, PA 15216

The downstream slope contains a bench at approximately mid-height which is sloped to drain from the center toward each abutment. Ponded water was observed on the bench at the junctions with both abutments. Some erosion of the embankment slope has occurred below the ponded areas.

e. Seepage: A flow of water estimated at 1 to 2 gallons per minute was observed in the toe drain channel. The origin of water appeared to be from below the groin riprap at the toe of the embankment. No sedimentation or movement of fine soil materials was observed.

(3) Discharge Channel: The spillway discharge channel was riprapped for a distance of approximately 700 feet below the overflow crest. Below the riprap, the channel is an earth cut in original ground. The channel contained an erosional gully caused by surface runoff from above and beyond the dam. The depth of erosion ranged from 6 to 12 inches.
